Manhole Inspection Summary

Manhole # S53AA_028MH

Insp Date: **7/17/08 8:15 AM**

Location Address: **3201 mcelderry st**

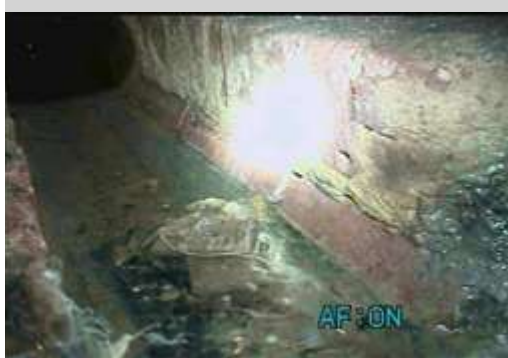
Miscellaneous

channel debris

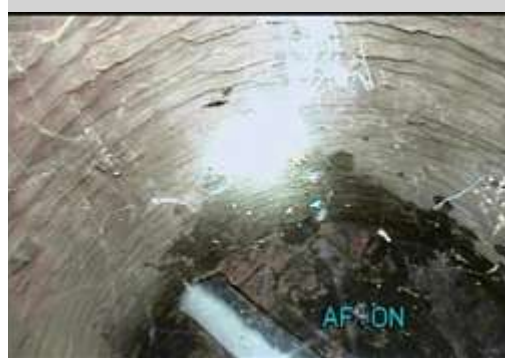
Defect 2

Count: **4** Missing: **4** ☒ **Corroded**

steps all missing

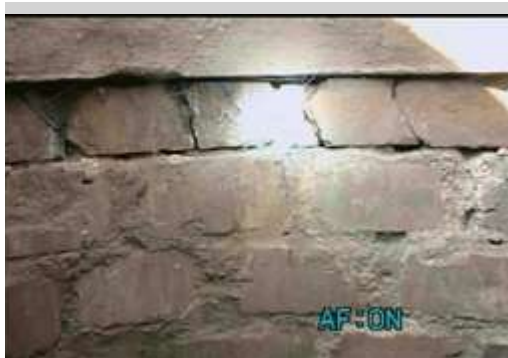
Defect 1

Condition: ☐ Sound ☒ **Cracked** ☐ Root Intrusion ☒ **Loose Brick** ☐ Deteriorated

chimney loose bricks, cracked, frame adj
